Re: Permit Compliance Evaluation Inspection of Northeastern Exploration, Inc. Well Davis #1-19, Montmorency County, Michigan; U.S. Environmental Protection Agency Permit Number MI-119-1I-C002

# UNDERGROUND INJECTION CONTROL INSPECTION REPORT

Permit Compliance Evaluation Inspection

Northeastern Exploration, Inc.

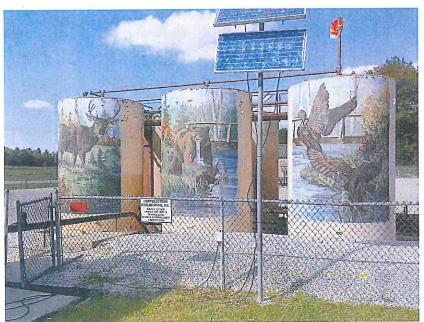
Photo 6: Northeastern Exploration Davis #1-19 (MI-119-1I-C002) injectate storage tanks. 9/13/17, 3:23 PM; IMG\_20170913\_152326.jpg

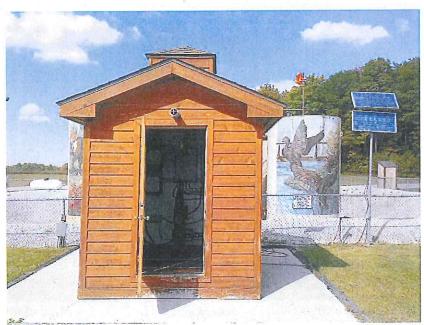
**Photo 7:** Northeastern Exploration Davis #1-19 (MI-119-1I-C002) injectate storage tanks and solar panels.

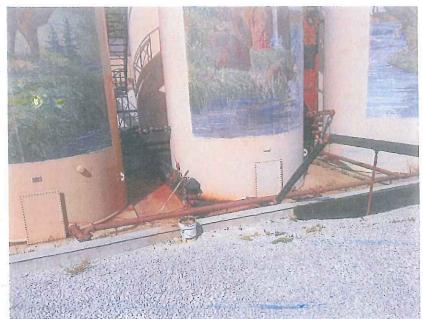
**Photo 12:** Northeastern Exploration Davis #1-19 (MI-119-1I-C002) injectate storage tank. 9/13/17, 3:25 PM; IMG\_20170913\_152520.jpg

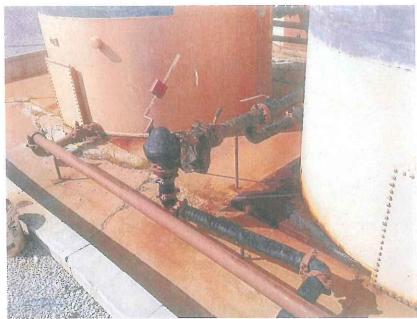
**Photo 20:** Northeastern Exploration Davis #1-19 (MI-119-1I-C002) injectate storage tank. 9/13/17, 3:34 PM; IMG\_20170913\_153429.jpg

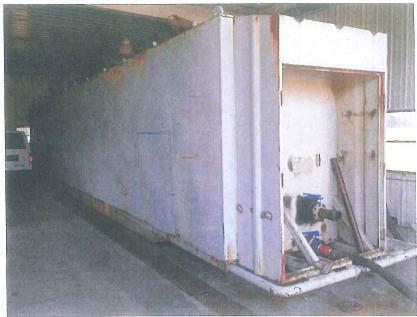
Mr. Husted stated that all waste arrives at the site via truck, and each load has a manifest or a bill of lading. Mr. Husted stated that each driver checks in with him at the office and presents their paperwork prior to driving back to unload at the wellsite. There are six 400-barrel storage tanks that receive the trucked waste prior to injection, and an additional seven frack tanks of 500 barrels each that may be utilized for injectate storage if needed. One of the 400 barrel tanks was beginning to show slight leakage at its base. Three shallow monitoring wells are also located at the site.

Photo 21: Northeastern Exploration Davis #1-19 (MI-119-1I-C002) injectate storage tank showing signs of slight leakage at the bottom rusty area. 9/13/17, 3:35 PM; IMG\_20170913\_153517.jpg
